CISPUS VALLEY BRIDGE  
(Forest Service Building No. 2306-3.6)  
Guilford Pinchot National Forest  
Randle  
Lewis County  
Washington

HAER No. WA-65

**Cispus Valley Bridge**  
(Forest Service Bridge No. 2306-3.6)

**Type of Structure:** Wooden Howe truss bridge, 200-foot span

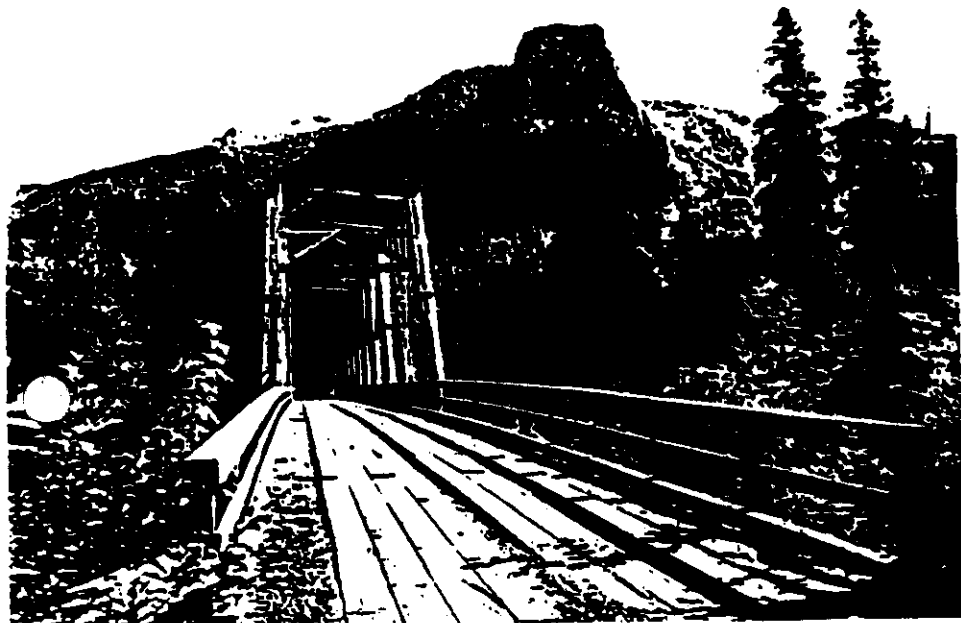
Northern bridge approach (1951)  
(earliest available photograph)
